Operation and Maintenance Report
January 2017 to December 2017

McCormick and Baxter Superfund Site

Portland, Oregon
ECSI Site No. 74

March 29, 2018
15670-10/Task 4

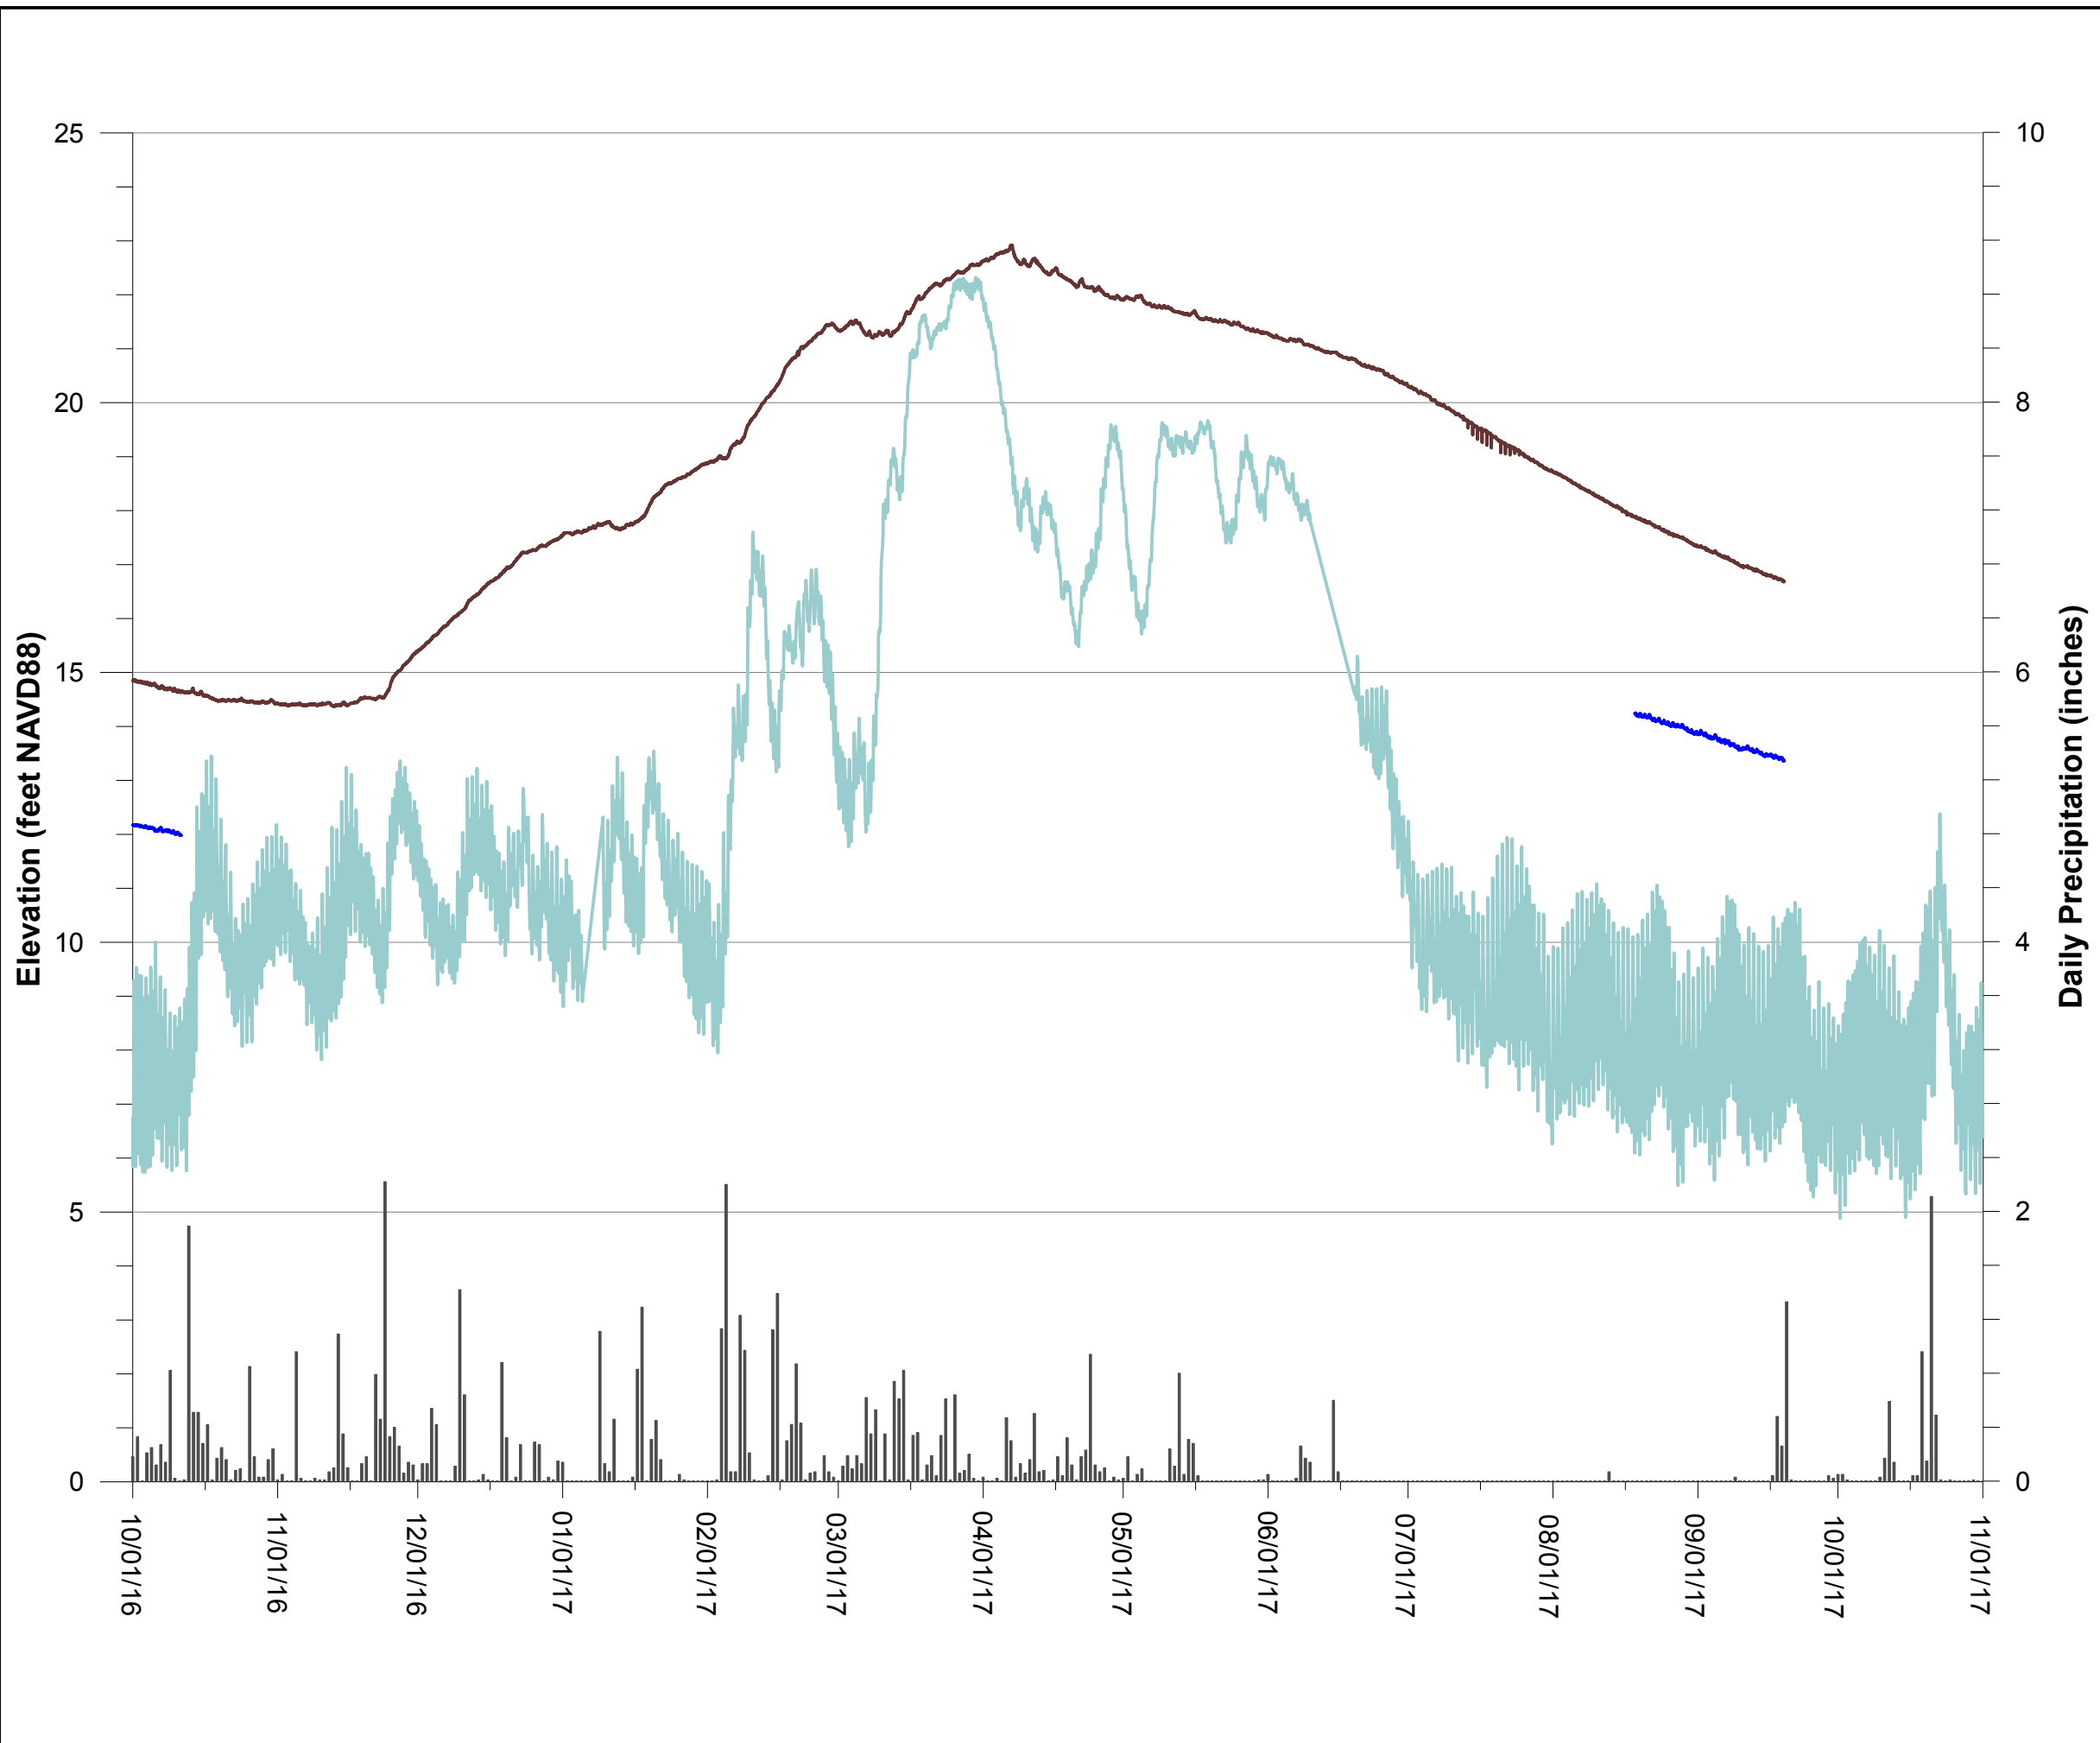
Figure 4-5:
2017 Groundwater Elevations
Monitoring Wells MW-52s and MW-53s

The break in MW-52s data (Figure 4-5) occurred as a result of water damage in the probe, which was identified in the June semiannual event. The transducer was sent in for repairs and re-installed in August. Currently, all transducers at the site are functional and installed in the wells shown on Figure 4-1.

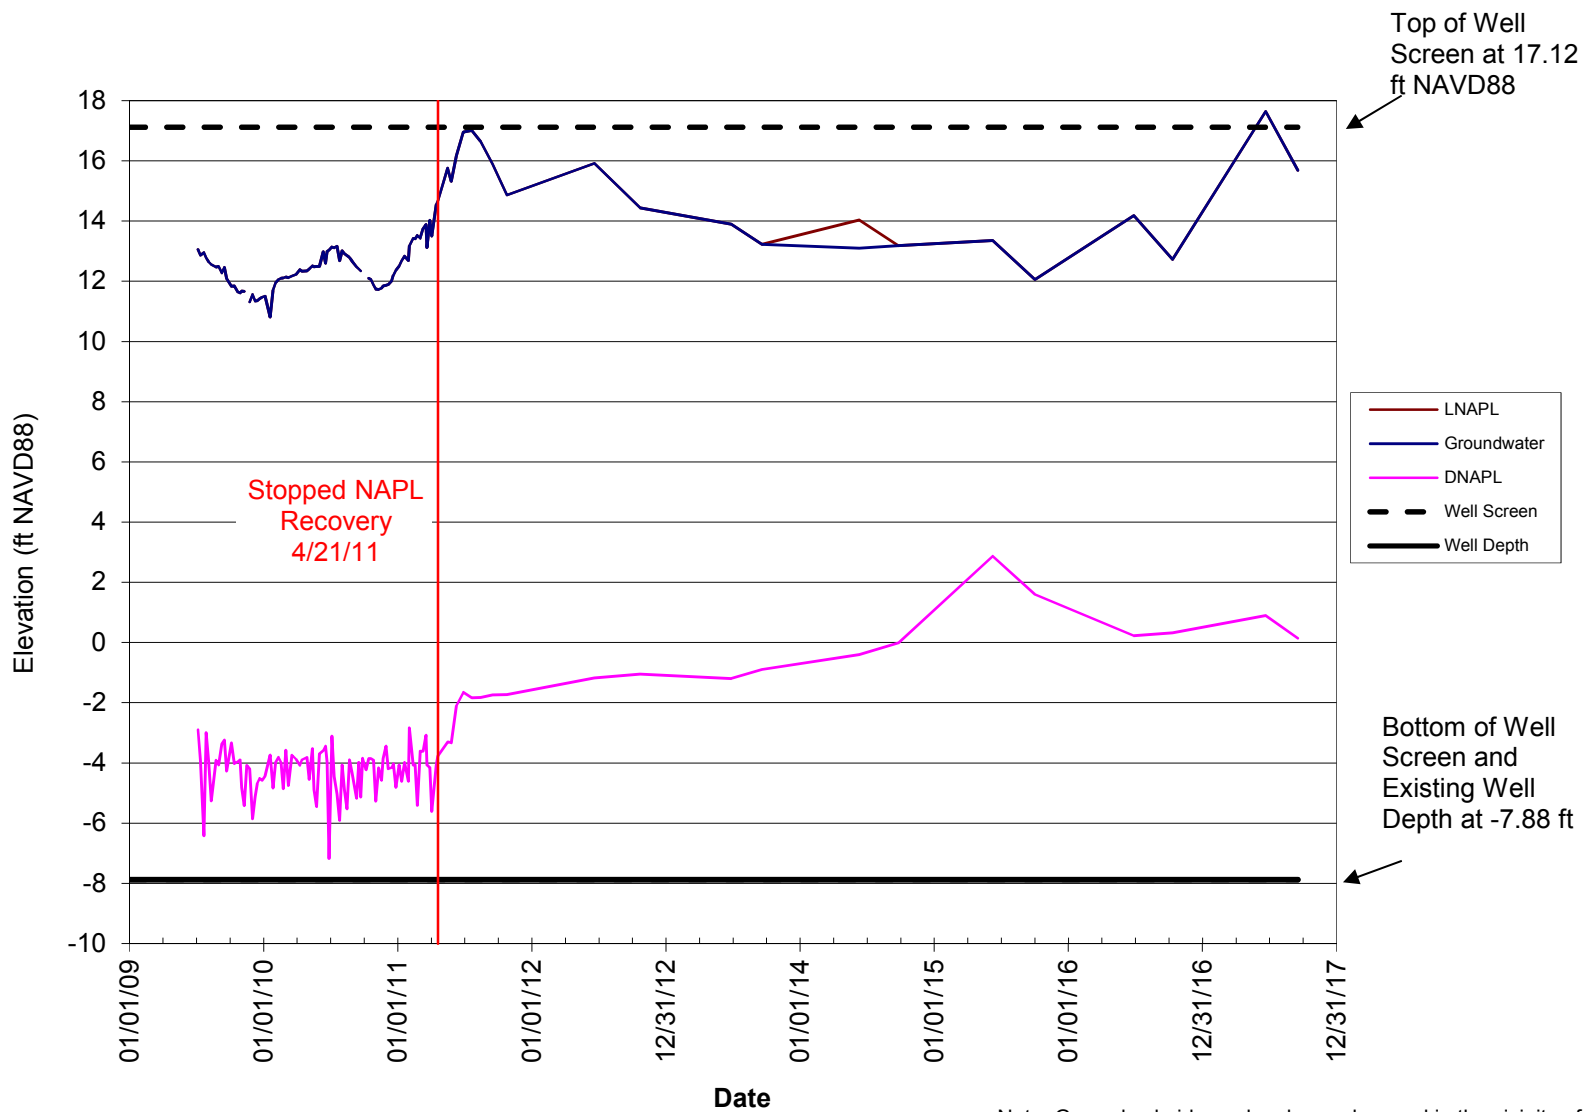
McCormick and Baxter Superfund Site
Portland, Oregon
**2009 to 2017 NAPL Thickness Plot
for Well EW-1s**

In June 2008, subsidence of the soil cap was observed near groundwater monitoring wells EW-1s and MW-23d. An upland site survey confirmed that the ground surface had subsided approximately 1 foot in a limited area around the wells between the time that the soil cap was installed in 2005 and 2008. A Subsidence in Upland Cap Memorandum (HC/GSI 2008) and an Additional Subsidence Monitoring Memorandum (HC/GSI 2009) present the results of the survey and additional investigation to determine the cause of the subsidence.

Based on elevated groundwater temperatures in well EW-1s (40 °C) and the large amount of buried woody debris in the area, it was suspected that aerobic degradation of woody debris was occurring and causing the ground surface subsidence. Decreasing groundwater levels within the barrier wall also may have contributed by opening a larger unsaturated zone that allows compaction. In 2009, the shallow well EW-1s was sealed to reduce the amount of oxygen reaching the unsaturated zone. After the well was sealed, subsidence slowed with no additional subsidence being observed over the past 5 years. The groundwater temperature dropped to approximately 21-23°C and has remained stable for the past 5 years. This temperature is still higher than groundwater from surrounding wells (approximately 13°C) indicating that some heat is still being produced in the subsurface near well EW-1s; this may be caused by anaerobic degradation, which generates less heat than aerobic degradation.

Note: Ground subsidence has been observed in the vicinity of EW-1s and the well casing has sunk over time. The screened interval and total well depth have been referenced to the most recent ground survey from September 2009. Given that the elevations are changing with time, the elevations shown are approximate.

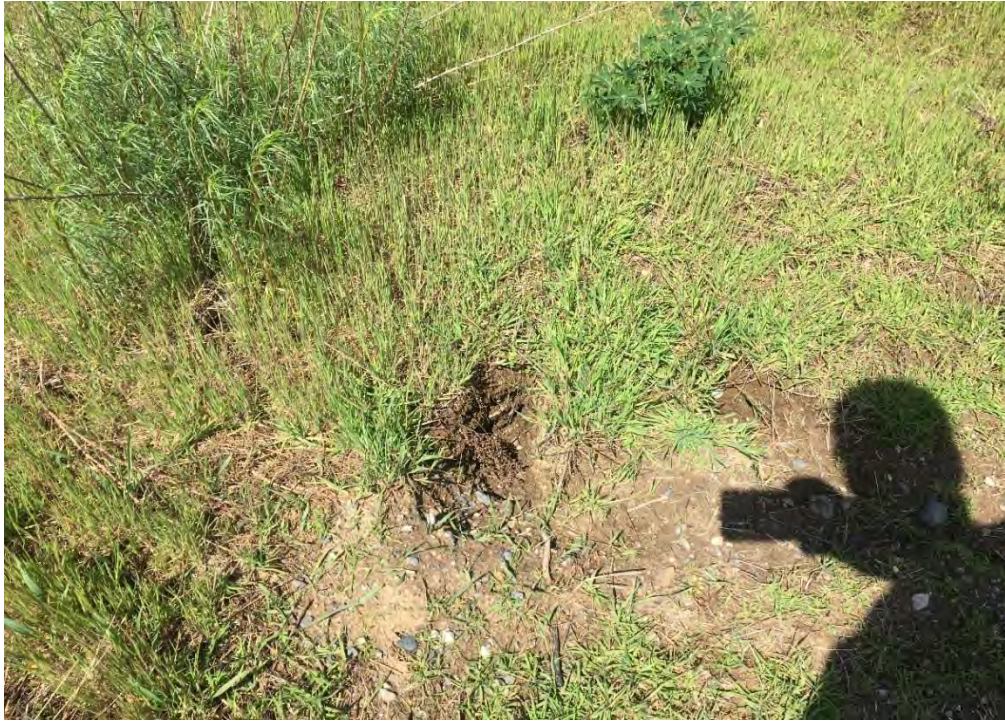
The upland soil cap provides habitat for rabbits, ground squirrels, Canada geese, several other species of birds, and coyotes. Despite placing gravel to fill gaps under the fence around the upland portion of the site, periodic burrowing continues to be observed under the fence and along the perimeter road. These burrows are filled as necessary and are not of major concern.

Photograph 1 – Animal burrow observed during April 2017 site inspection.

Following the July 20, 2017, site inspection, burrows were filled around the perimeter fence. Additional site infrastructure activities were conducted. The power to the trailers was disconnected and the alarm system removed on January 26, 2017. Oregon Demolition removed and took title to the two job trailers, which were deteriorating and obsolete, on February 9, 2017 (Photograph 2; Appendix A). The backflow preventer on the waterline was tested on September 15, 2017.

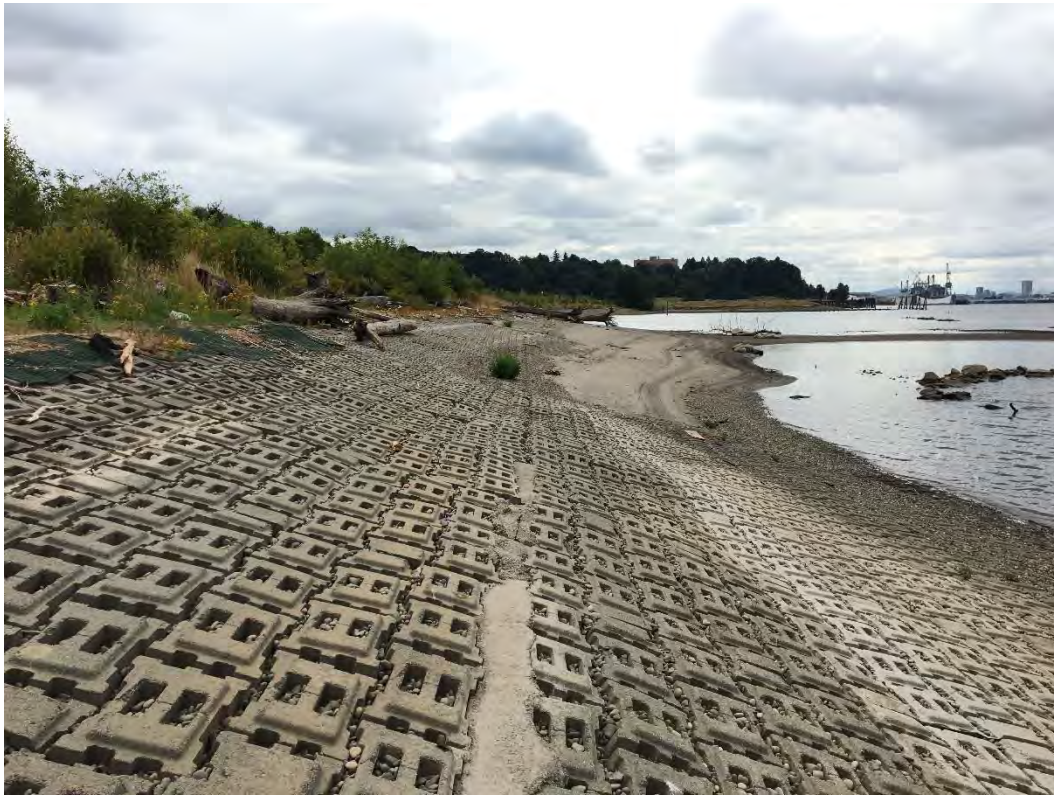
Habitat enhancement features such as boulder clusters and sand cover as a biotic layer are design elements of the sediment cap. Large woody debris also provides habitat enhancement along the shoreline and in the Riparian Area above the shoreline. The distribution of sand cover over the ACB is similar to previous years. Originally, sand was placed over a large portion of the shoreline and Willamette Cove ACB armoring, but high river flow conditions and wake from passing boats have washed sand from the ACB where the bank slopes are steeper. Rounded gravel (1-1/2-inch-minus) was placed within the ACB voids along a large portion of the shoreline and Willamette Cove in October 2012. The gravel has largely remained in place through 2017; however, some has washed down steeper shorelines and has settled onto lower ACB surfaces. Shoreline conditions and the distribution of the ACB gravel are shown in the Photograph Log (Photograph 3, Appendix A).

Photograph 3 – ACB observed during the July 2017 site inspection.

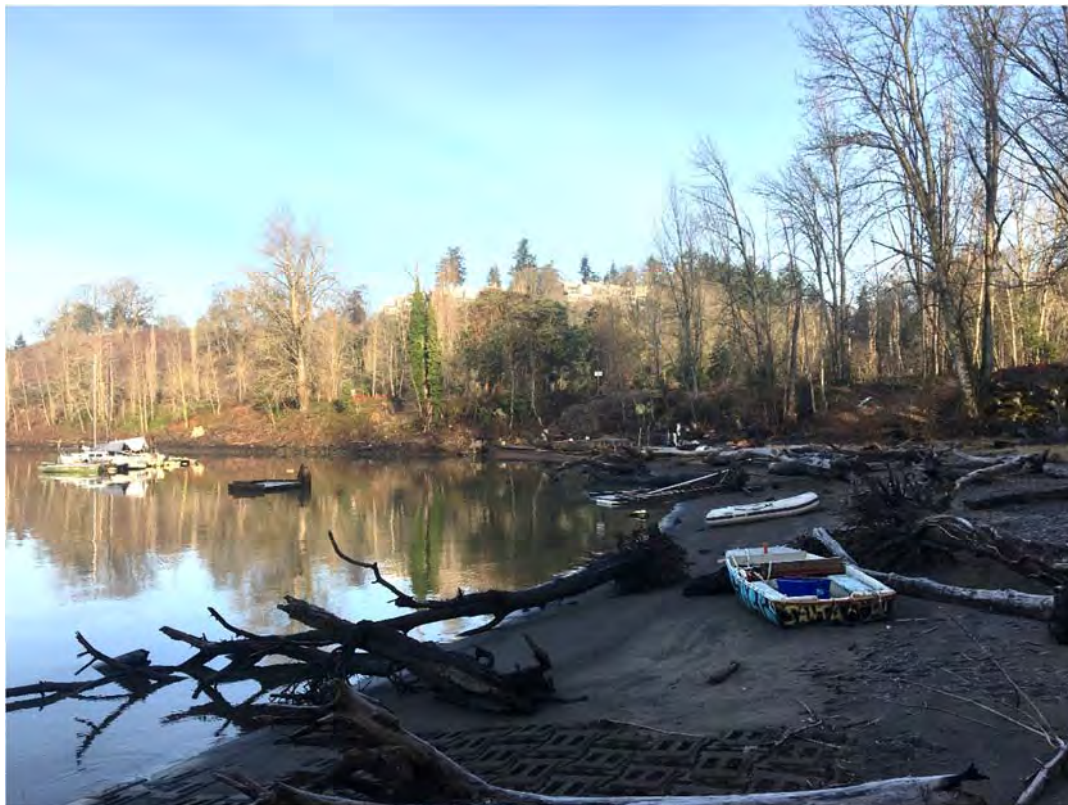
The shoreline along the site and in the Willamette Cove is accessible and is used by the public for various forms of recreation. Throughout 2017, shoreline trash and graffiti were observed, including scattered car parts above the Riparian Area. Numerous dilapidated boats (used as dwellings) were also seen anchored in the Willamette Cove during every site visit (Photograph 4, Appendix A). Boats were not observed to be anchored on the sediment cap during site inspections. No effects to the sediment cap were observed from mooring or from physical contact with these boats on the sediment cap. The US Coast Guard and Oregon State Marine Board rules prohibit anchoring on the sediment cap.

Photograph 4 – Transient vessel in Willamette Cove – January 2017.

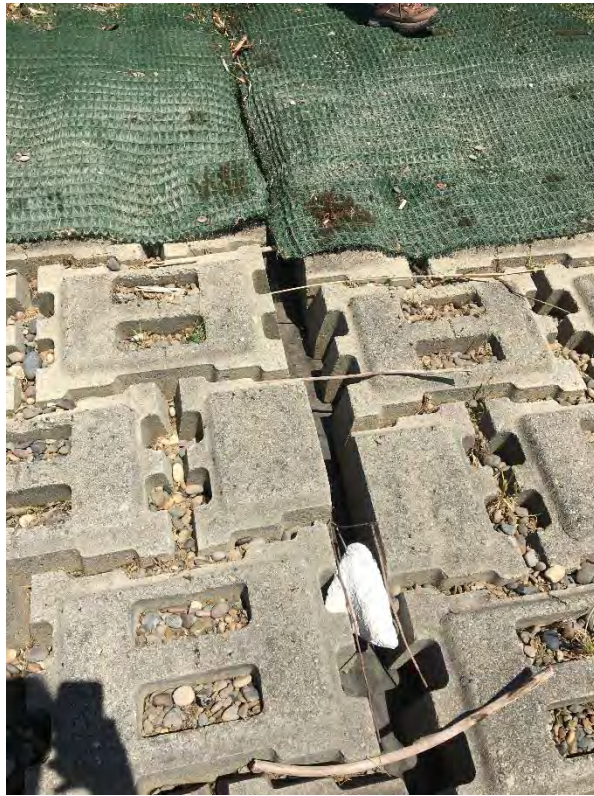
Photograph 9 – Gap observed in ACB during April 2017 site inspection.

The sediment cap was designed to be generally maintenance free. ACB repairs were completed in September 2017 that consisted of placing concrete in 11 areas where 2- to 4-inch voids developed between ACB mats (Photograph 9, Appendix A). The repairs were completed by placing concrete in the voids to reduce the trip hazard and protect the cap. Repairs were completed when river levels were low, allowing the concrete ample time to cure and eliminating the chance for runoff to the river. Additionally, riparian vegetation at the upper portions of the sediment cap required watering in August 2017 (see Section 5.3 for further discussion).

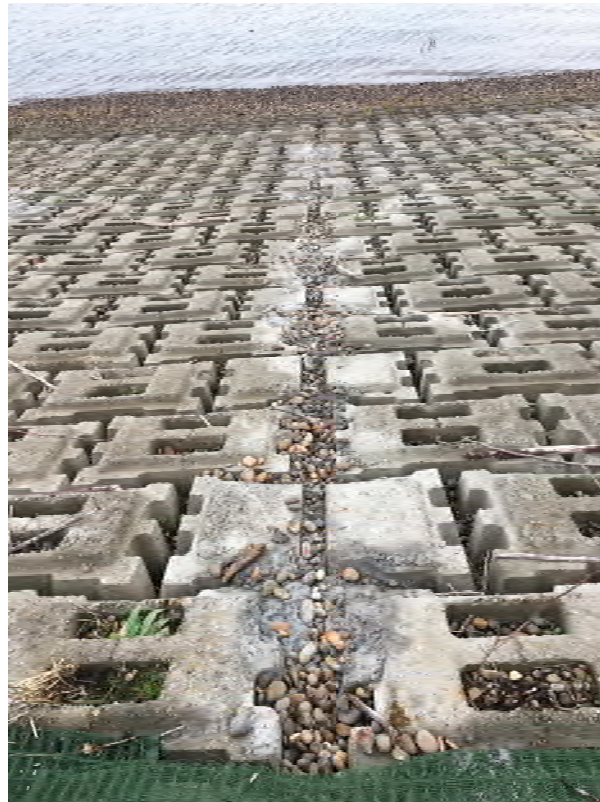
Photograph 11 – ACB repairs observed during October 2017 site inspection.

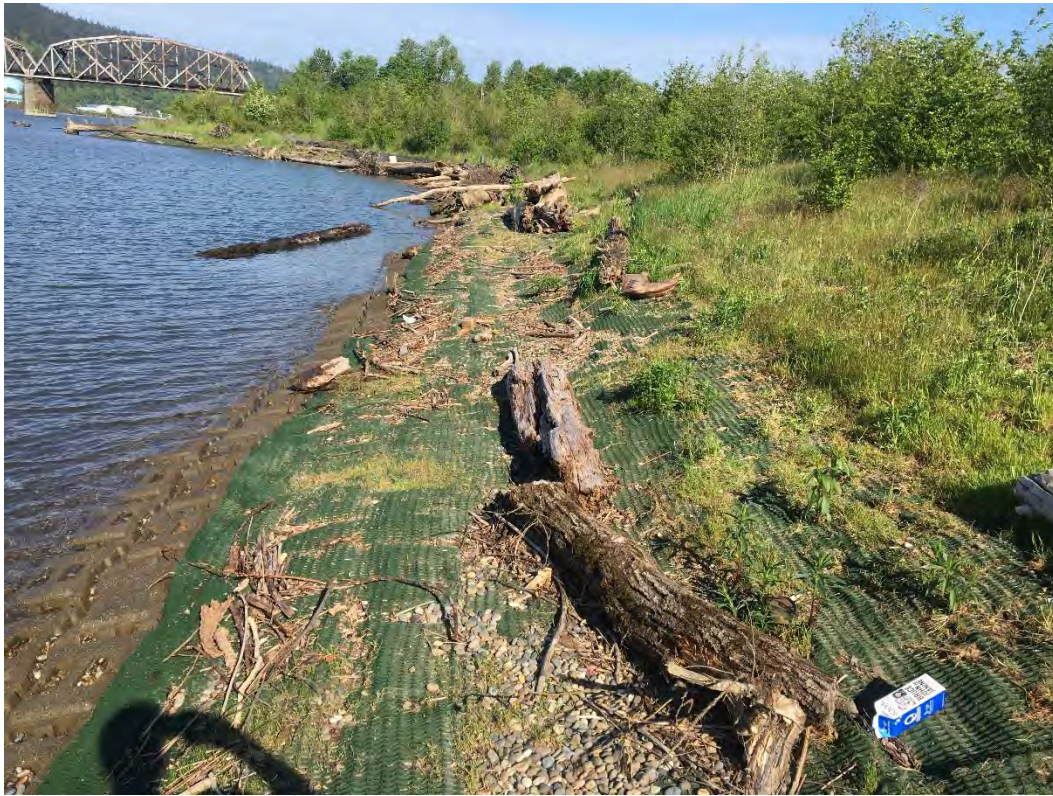
Photograph 13 – Lower portion of the ACB armoring – May 2017.

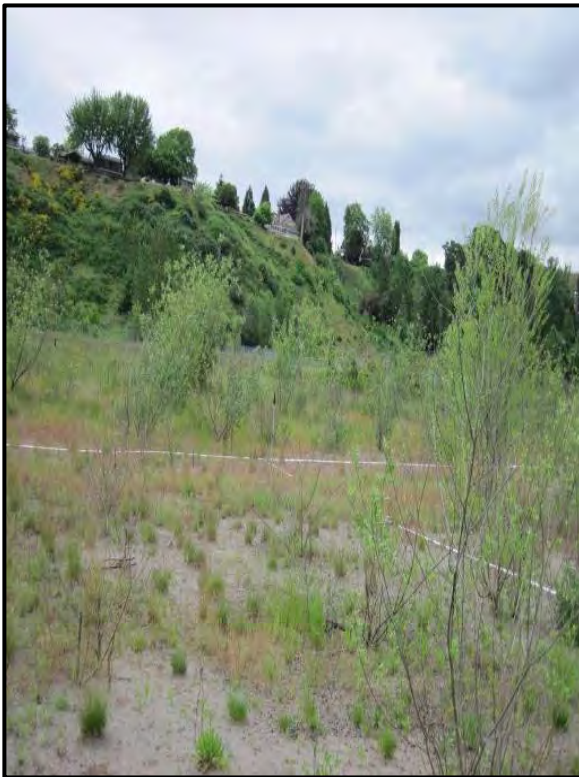
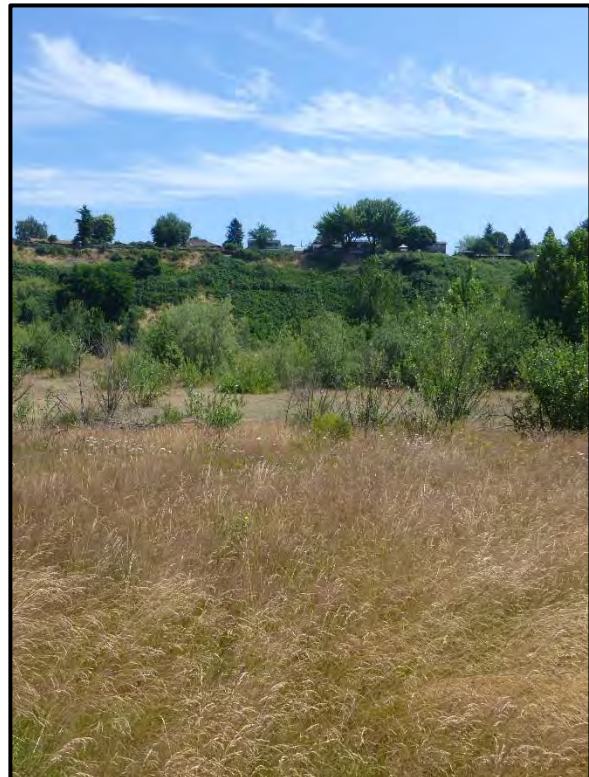
Photograph 4 – View of stormwater pond. Willow and alder have increased in size, although most of the pond remains barren or vegetated with grasses. The irrigation system was removed in 2016. Taken looking northeast from Photograph Location 4 comparing baseline and current conditions. (Left - June 2011, Right - June 2017)

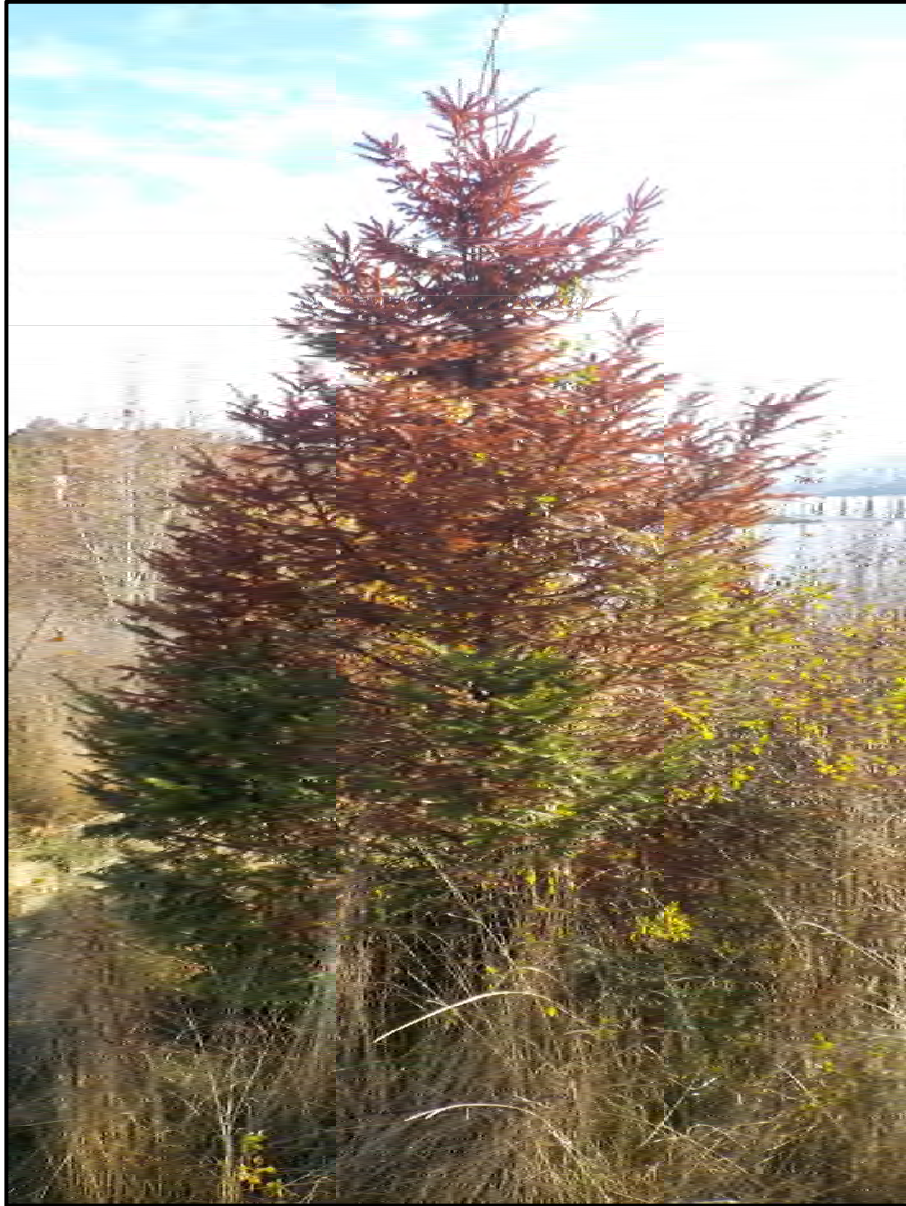
Photograph 11 – Middle portion of upper riparian area, looking south. A Grand Fir exhibiting drought and/or disease stress. (October 2017)
